PRINCETON NURSERIES KINGSTON SITE CULTURAL LANDSCAPE REPORT  
CHAPTER III: RECENT HISTORY & EXISTING LANDSCAPE

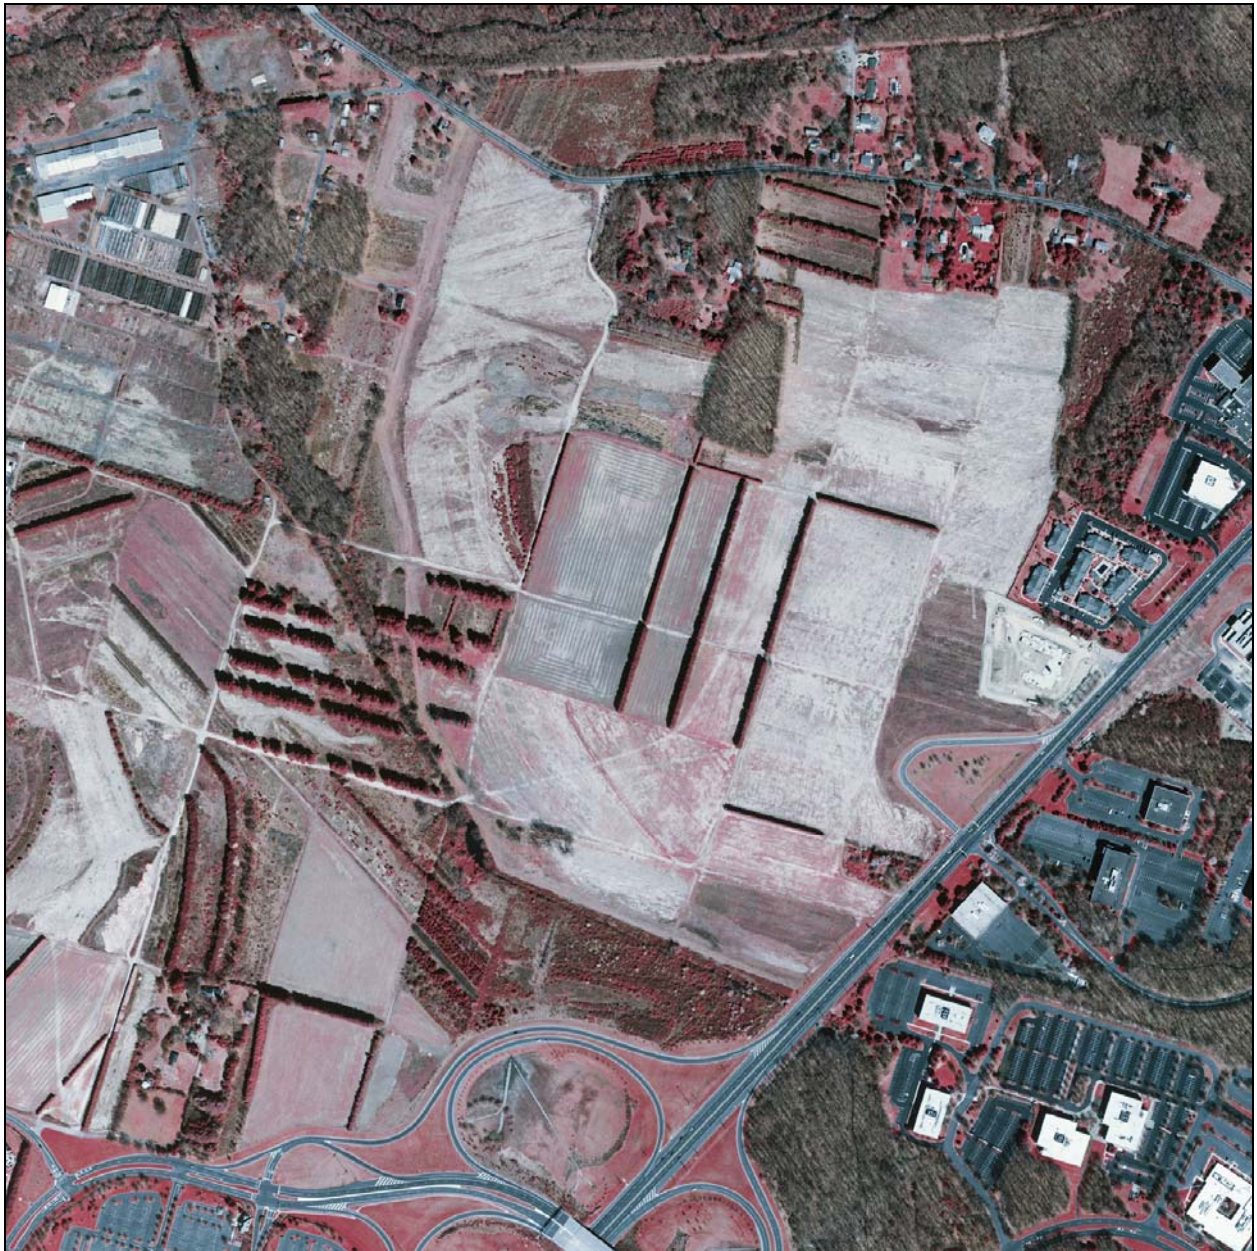
Figure III.1. This 2002 aerial shows a portion of the former Kingston Site. The operation core is visible at the upper left-hand corner. During the most recent period, many greenhouses and poly houses south of the propagation house have been removed from the landscape. Courtesy New Jersey Geography Network. (R-PRN-NJGIN-G10B7-2002Aerial.jpg)

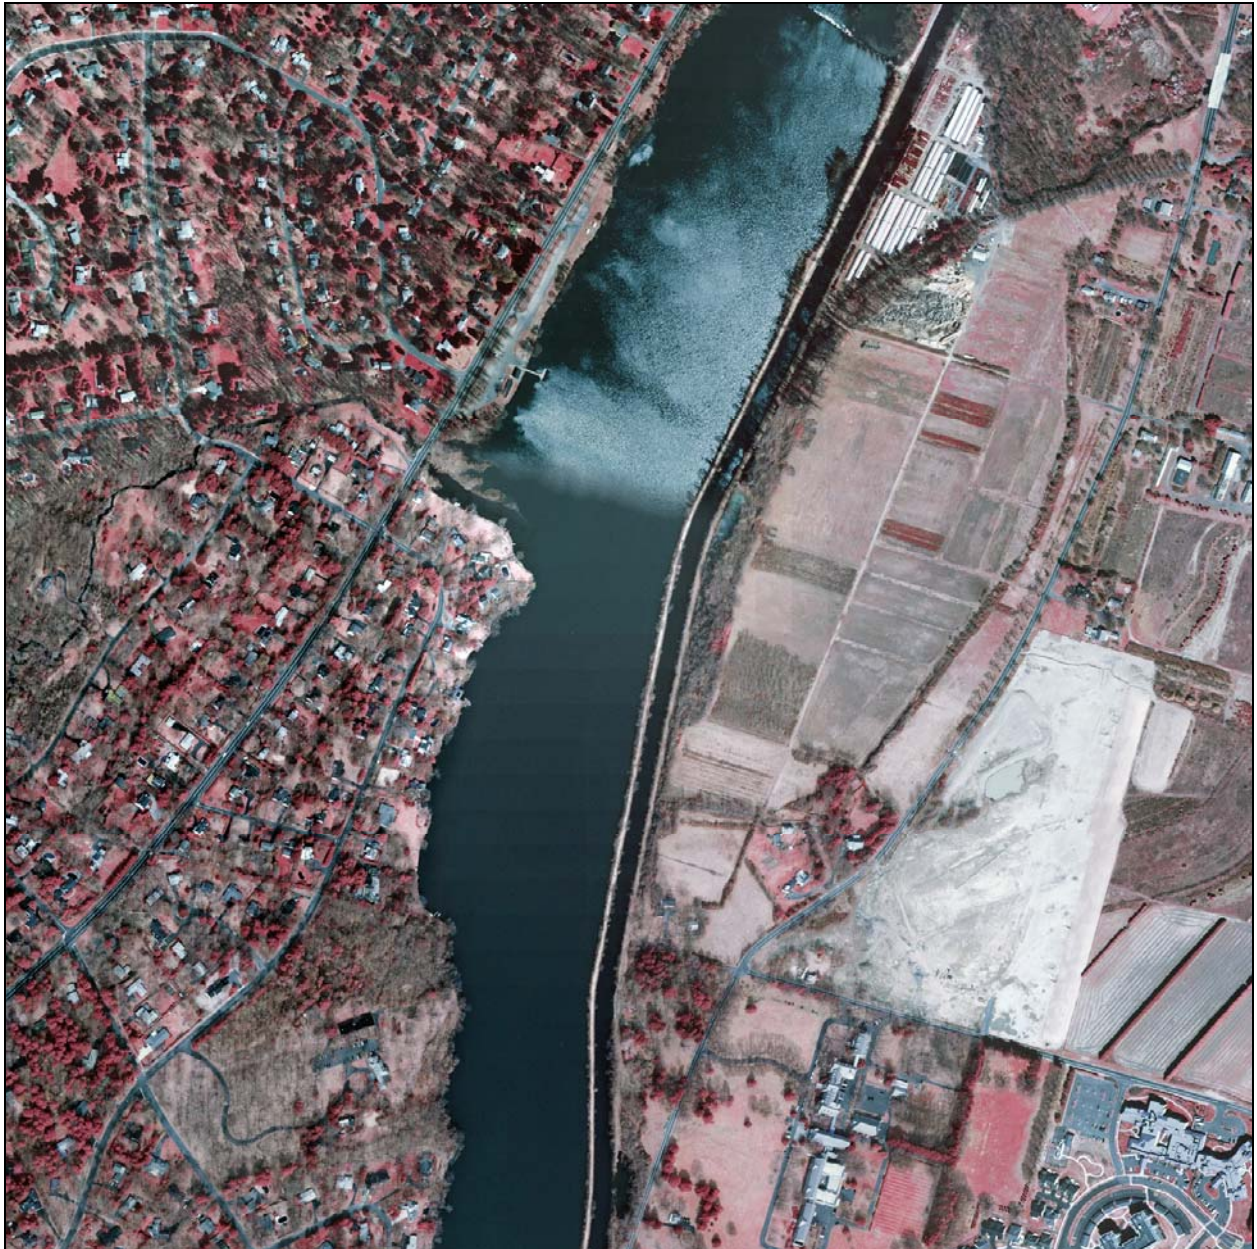
Figure III.2. Another 2002 aerial shows the western portion of the former Kingston Site. The 220-unit Barclay Square subdivision is partially visible at the lower right-hand corner. While extant windrows remain evident, it is likely that many of the production fields began transition to old field succession. Courtesy New Jersey Geography Network. (R-PRN-NJGIN-G10B6-2002Aerial.jpg)

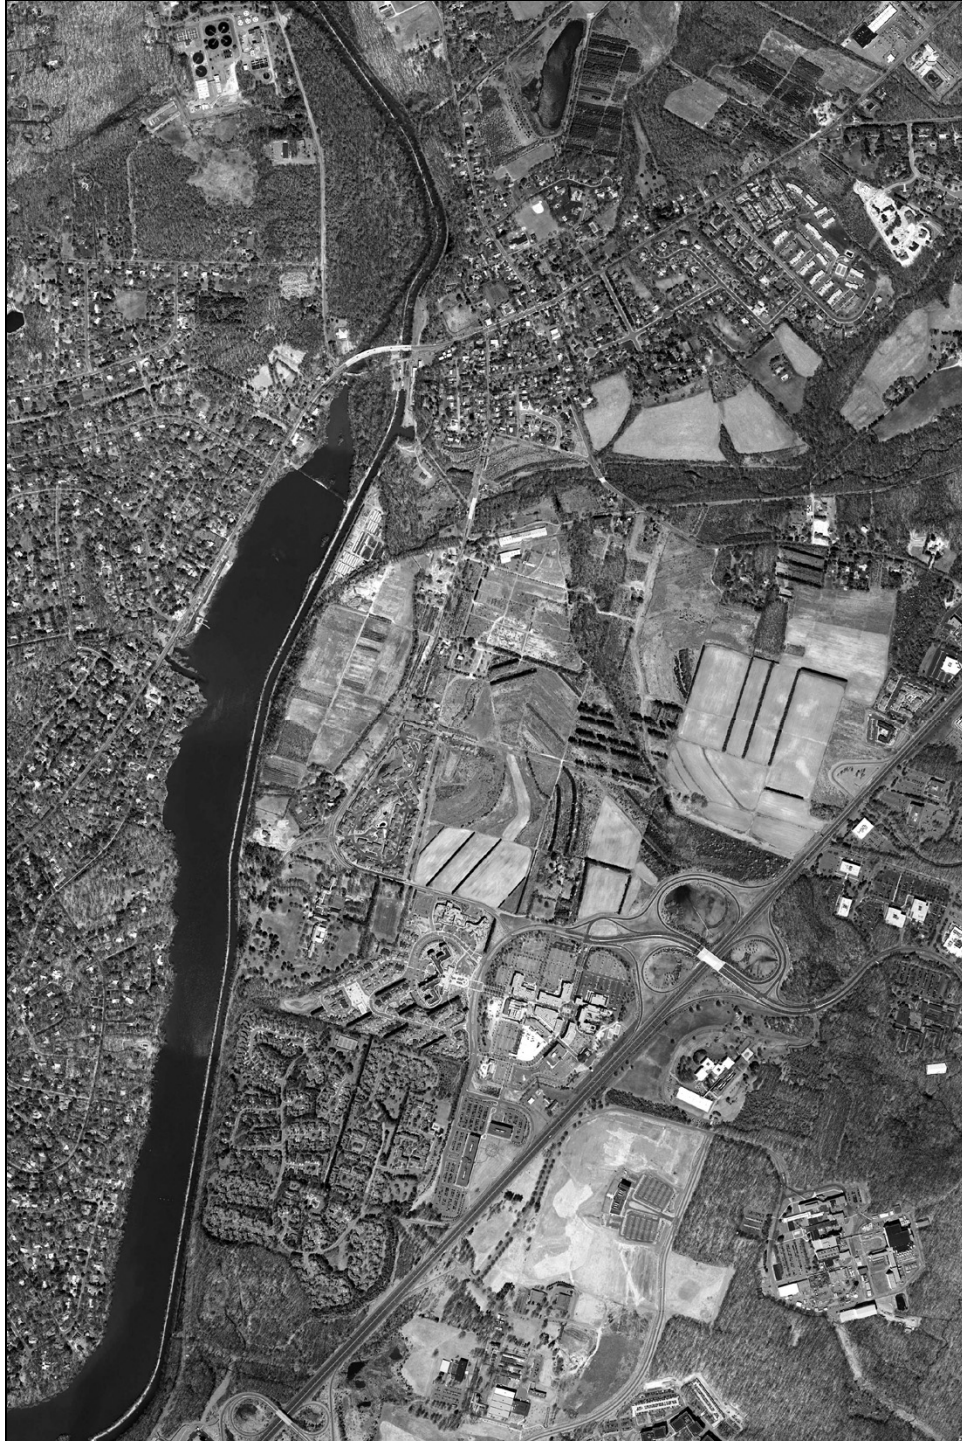
Figure III.3. A 2007 aerial reveals the most recent changes in the former nursery landscape. A considerable amount of dense development has occurred in the southern portion. The remaining greenhouses and poly houses were removed with only the propagation house and original eight greenhouses remaining. Some informal circulation alignments are evident within the former core. The cluster of buildings that included the dormitory and pool has also been removed. Courtesy New Jersey Geography Network. (R-PRN-NJGIN-2007Aerial.jpg)

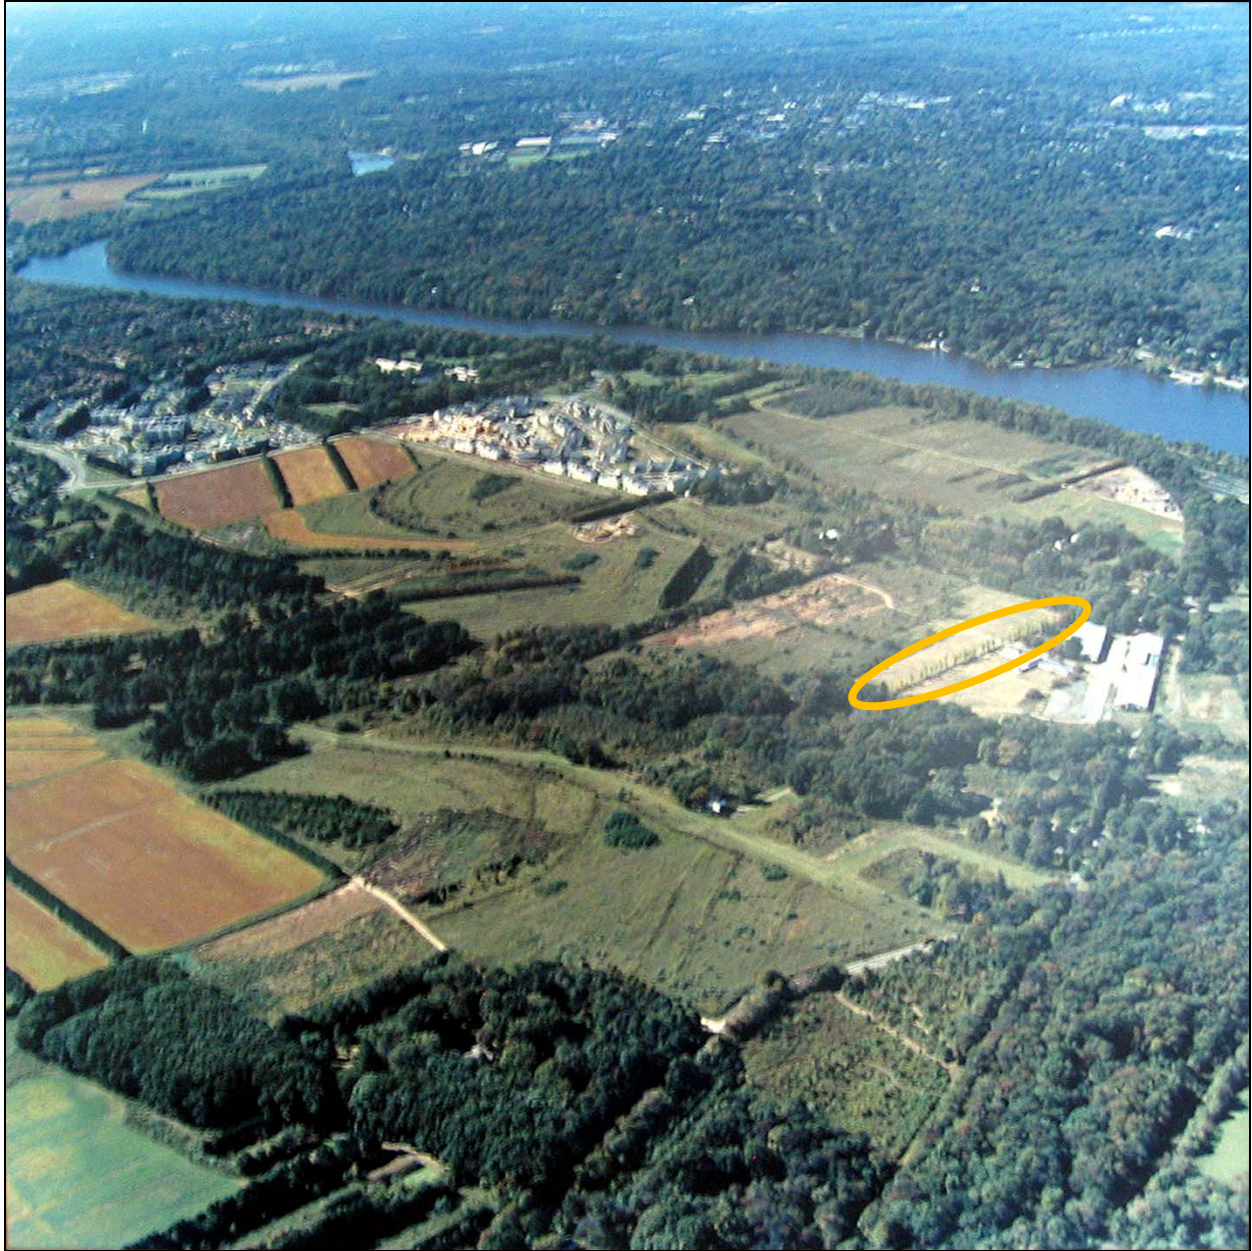
Figure III.4. This circa 2003 oblique aerial looks southwest across the former nursery core, depicting details of changes made in the landscape. Two housing developments are visible at the top of the image. The cluster of greenhouses and poly houses has been removed. The former site of this cluster is evident through the disturbed ground plane. The transition of production fields to mixed meadow and old field succession is also evident. In spite of changes, many historic features remain, including the packing shed, tree storage building, and propagation house. The Princeton Sentry gingko tree row (circled in orange) remains a visually prominent feature. Courtesy Delaware & Raritan Canal State Park. (R-PRN-DRC-Apr09-0004-c2003-adjust.jpg)

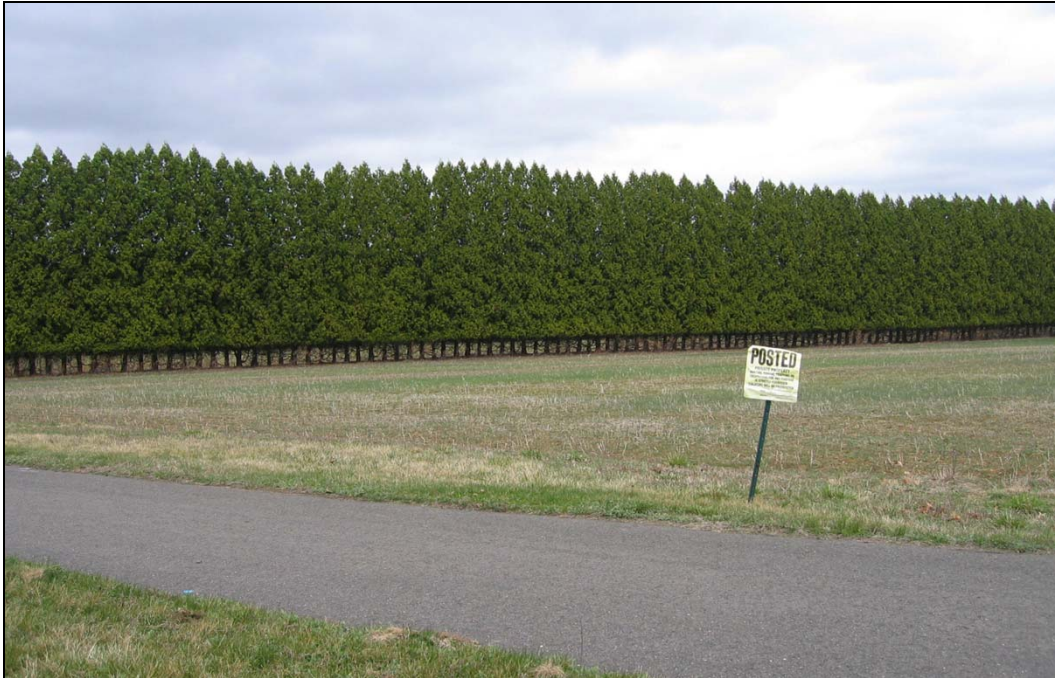
Figure III.5. While many landscape features have been lost over time, the visually prominent windrows remain throughout the former nursery lands. Courtesy Heritage Landscapes. (R-PRN\_20090401\_0021.JPG)

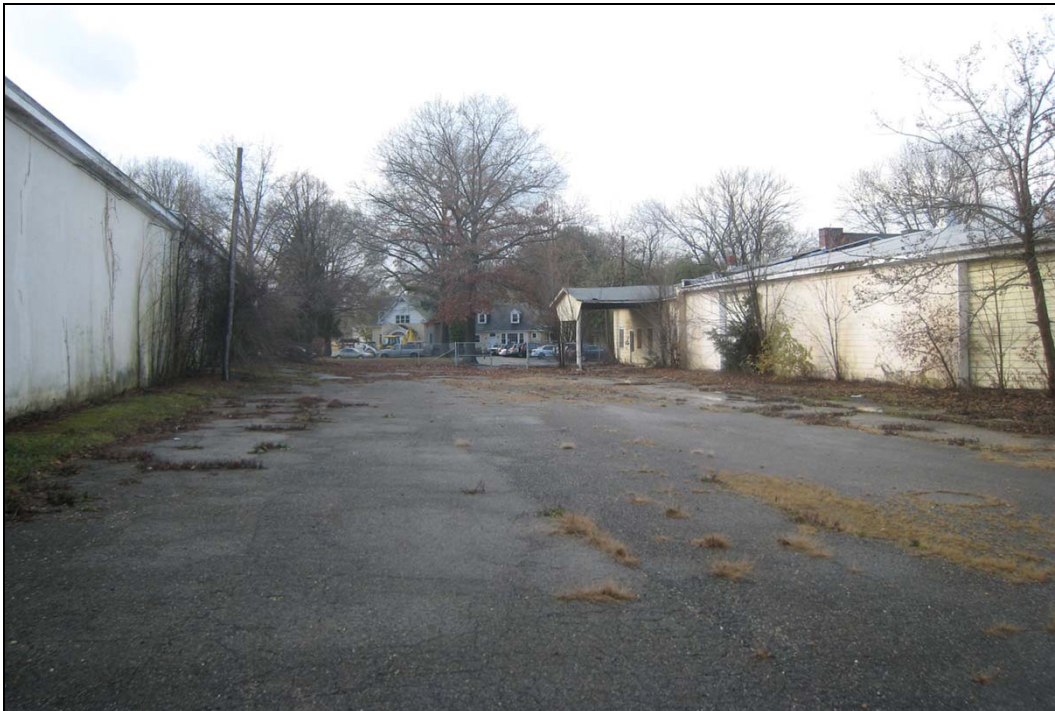
Figure III.6. The linear spatial quality seen throughout the landscape is illustrated in this image. The packing shed and tree building are set parallel with the asphalt area. The office, visible in the background, is set perpendicularly to the features in the foreground. Courtesy Heritage Landscape. (R-PN-HL-11-25-2008\_071.JPG)

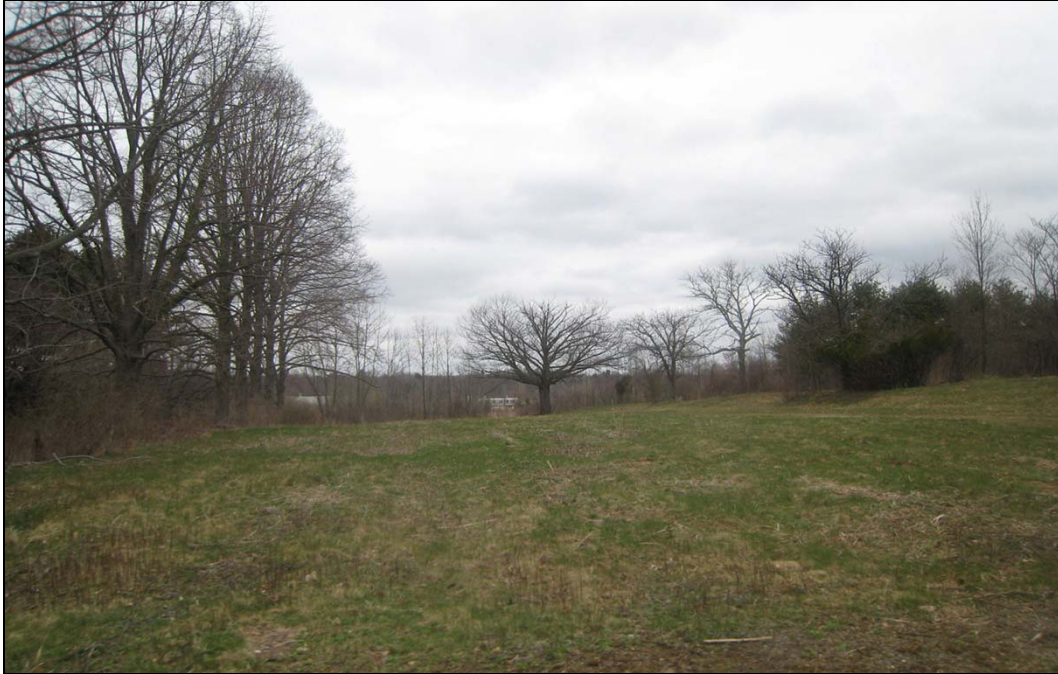
Figure III.7. This field is the former site of a cluster of buildings including the worker dormitory and swimming pool. While the building cluster has been removed, the open field with vegetation along the perimeter conveys the historic spatial organization. Courtesy Heritage Landscapes. (R-PRN-Apr09-0035.jpg)

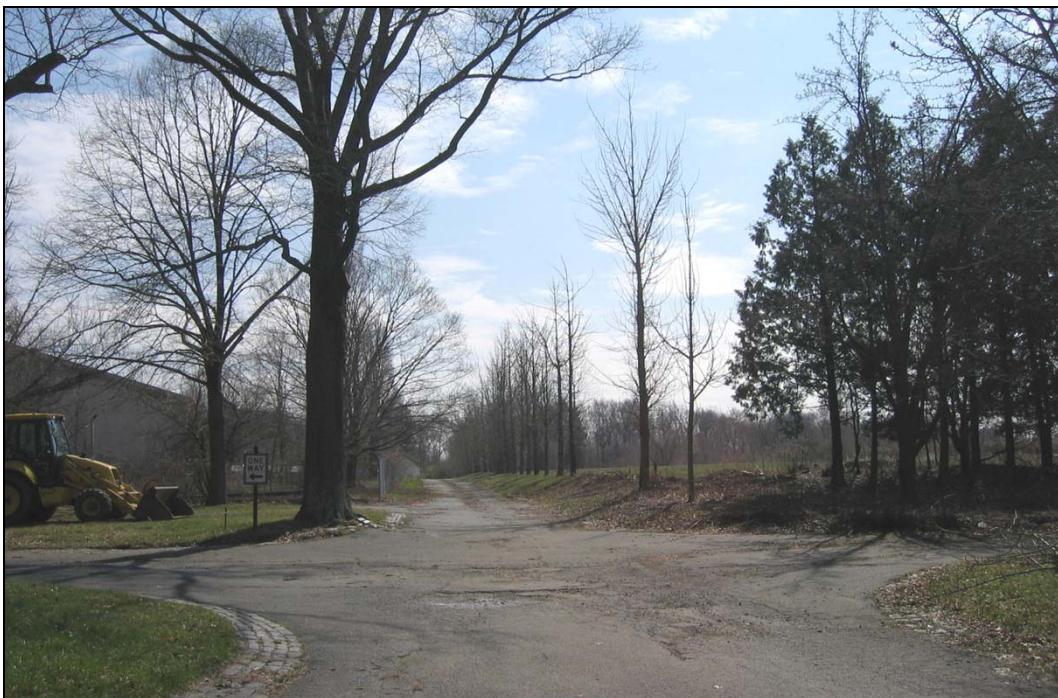
Figure III.89. This view looks east past the entry landscape and toward the former nursery core. A stately row of Princeton Sentry ginkgo lines the south (right) side of the road, framing linear views through the space. Remnant stone curbing is evident around the turf island in the foreground. Courtesy Heritage Landscapes. (R-PRN\_20090402\_0043.jpg)

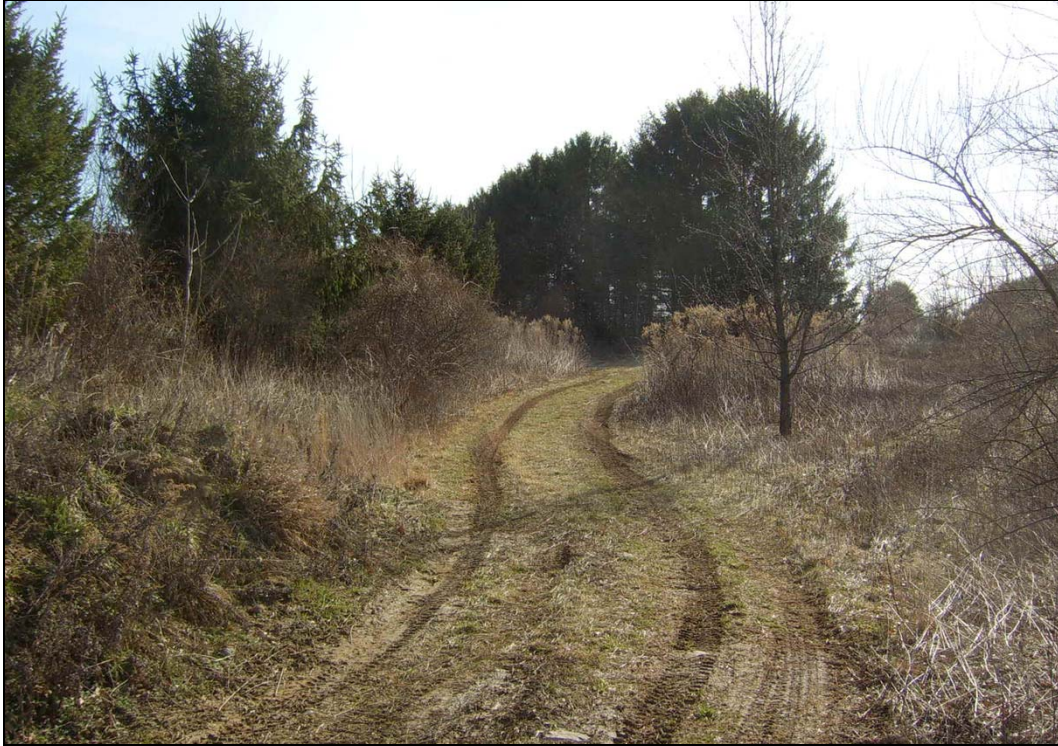
Figure III.9. Mature planted trees and volunteer growth frame and enclose views along this gently curving road, located at the eastern edge of Mapleton Preserve. Courtesy Robert von Zumbusch. (R-PRN-RvZ-07013 D9-012.jpg)

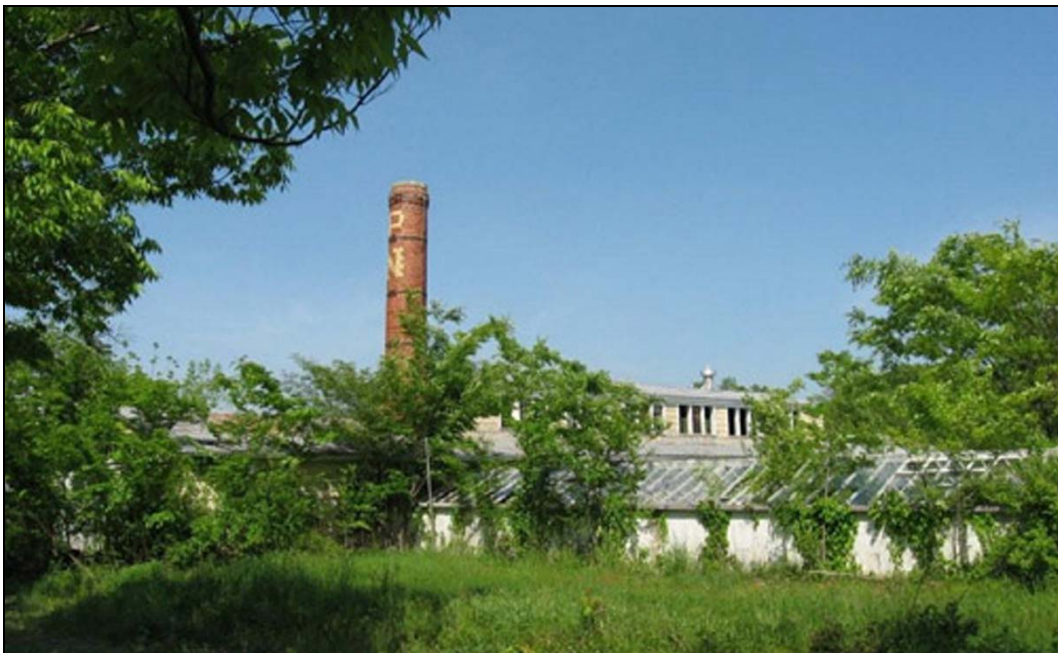
Figure III.10. The propagation house and eight original greenhouses are valuable historic features. Volunteer growth obscures views of these important landscape features and adversely impacts the built resources. Courtesy Robert von Zumbusch. (R-PRN-RvZ-PropHouse-Veg.jpg)

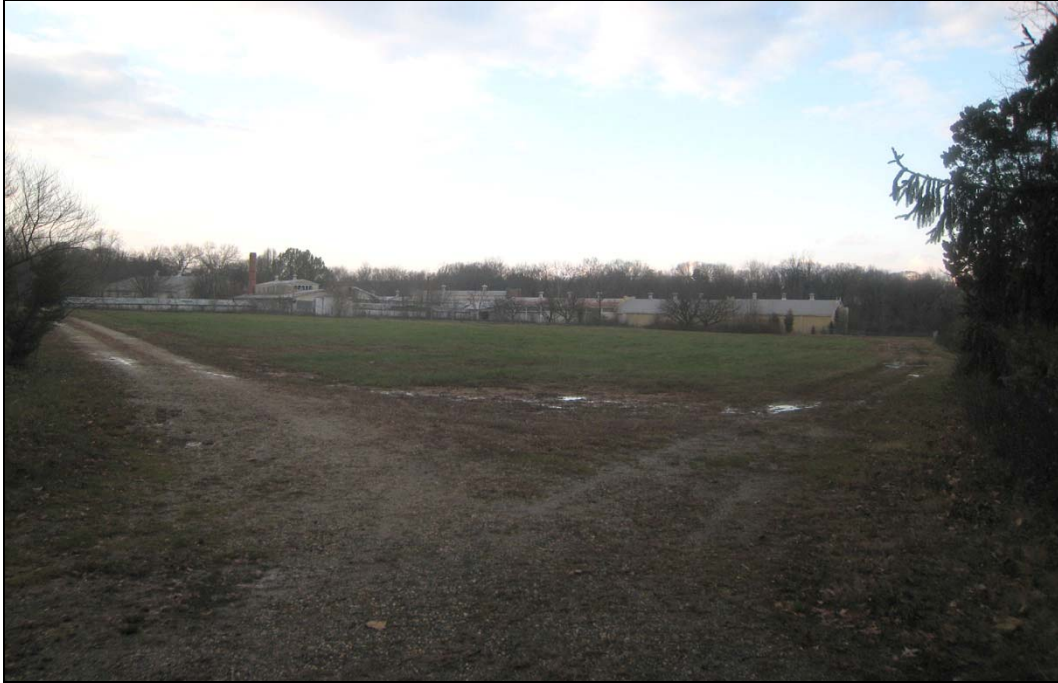
Figure III.11. This view looks northwest from the southeastern corner of Mapleton Preserve. The mown turf area was once the site of dozens of greenhouses and the potting shed. Intersecting gravel roads continue to define the spatial patterns of the former operation core. Courtesy Heritage Landscapes. (R-PN-HL-11-25-2008\_078-adj.jpg)

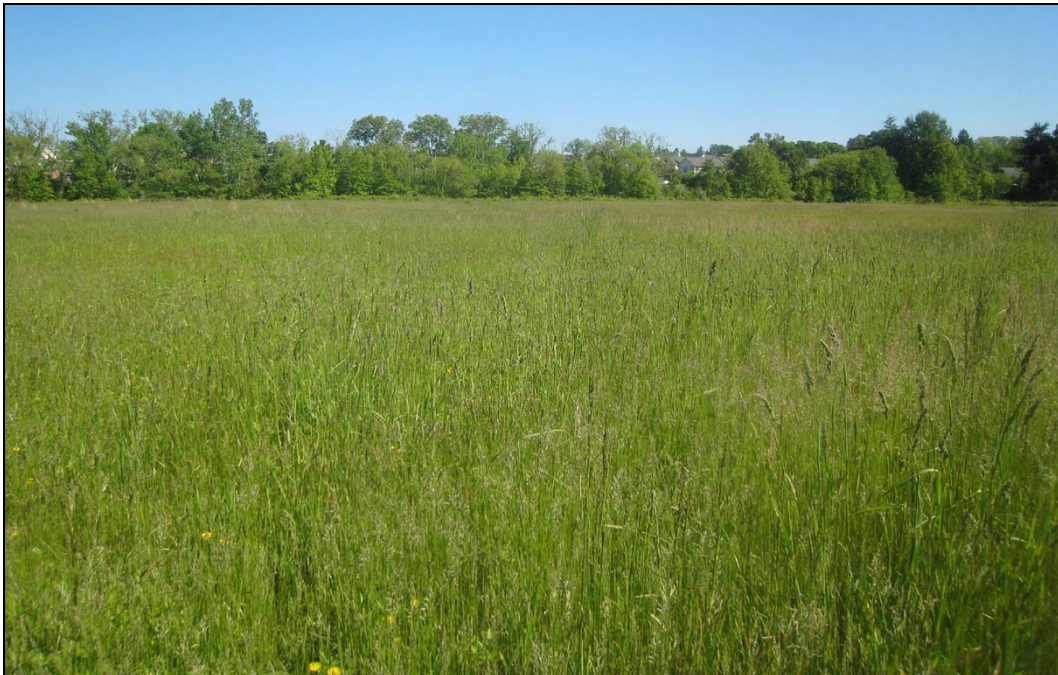
Figure III.12. This former production field, located west of Mapleton Road, displays taller, mixed meadow species grass. The height of the vegetation indicates it has not been mown as recently as some areas in the former core. Woody growth is not yet evident. Courtesy Heritage Landscapes. (R-PRN-19May09-0159.JPG)

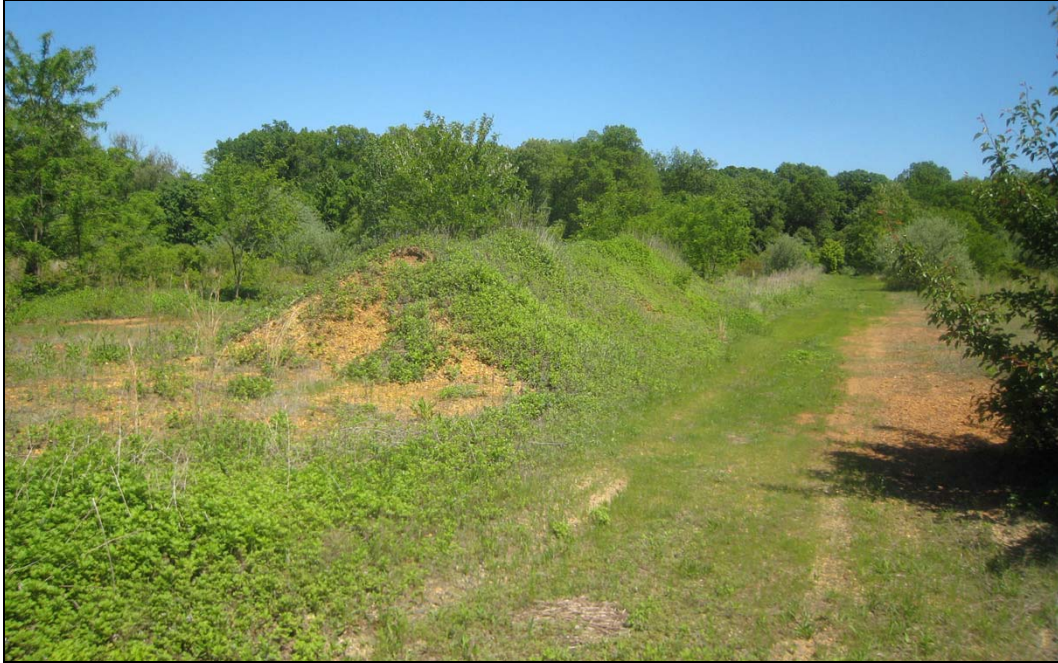
Figure III.13. A mound of earth with low-growing vegetation has been bermed along the north side of a former access way. The access road is surfaced with short, mown turf. Courtesy Heritage Landscapes. (R-PRN-19May09-0111.JPG)

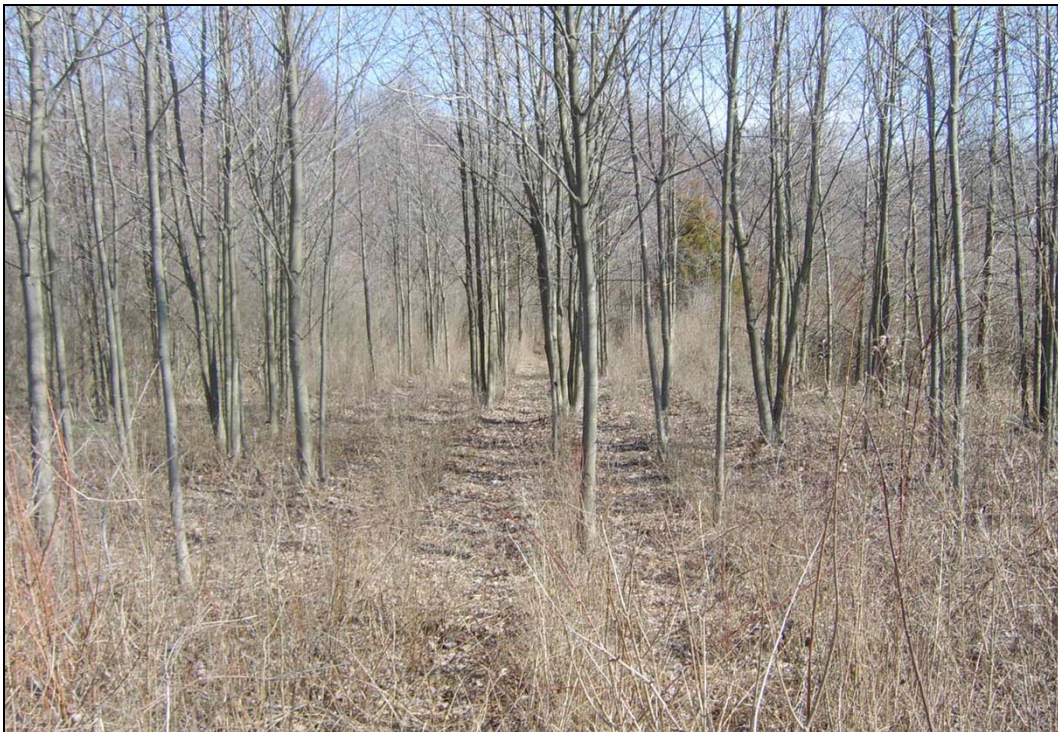
Figure III.14. These tree rows are among the little remnant stock evident in the landscape today. As volunteer growth continues to spread throughout the ground plane, this linear planting will become obscured. Courtesy Robert von Zumbusch. (R-PRN-RvZ-07013 D9-042.jpg)

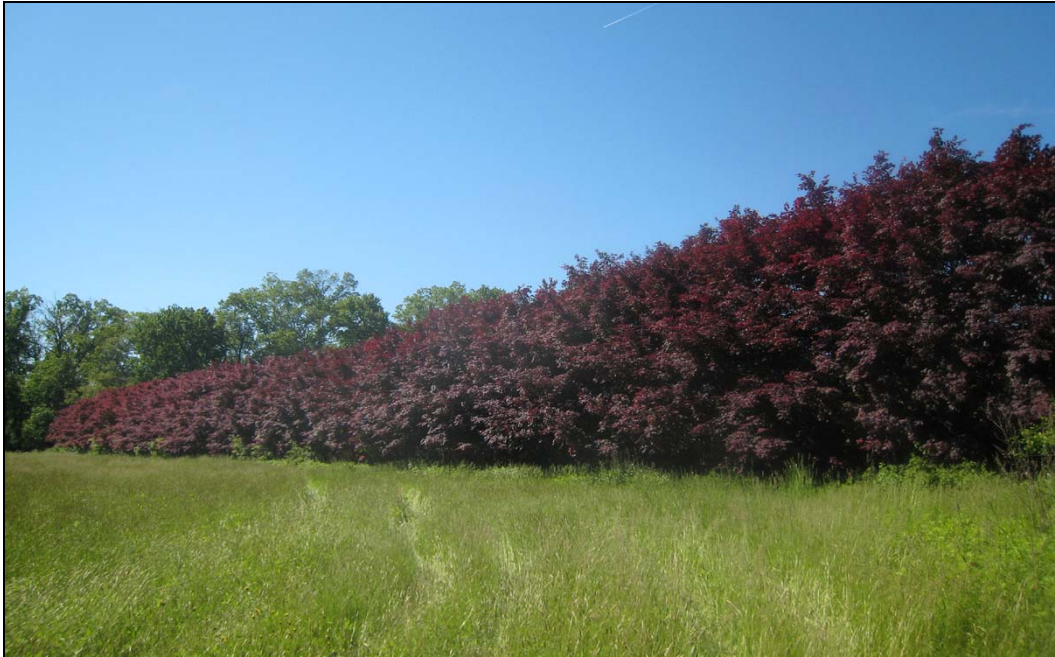
Figure III.15. Two prominent rows of remnant nursery stock are evident in the lands west of Mapleton Road. Here a row of Japanese maple forms a striking landscape feature. Courtesy Heritage Landscapes. (R-PRN-19May09-0157.JPG)

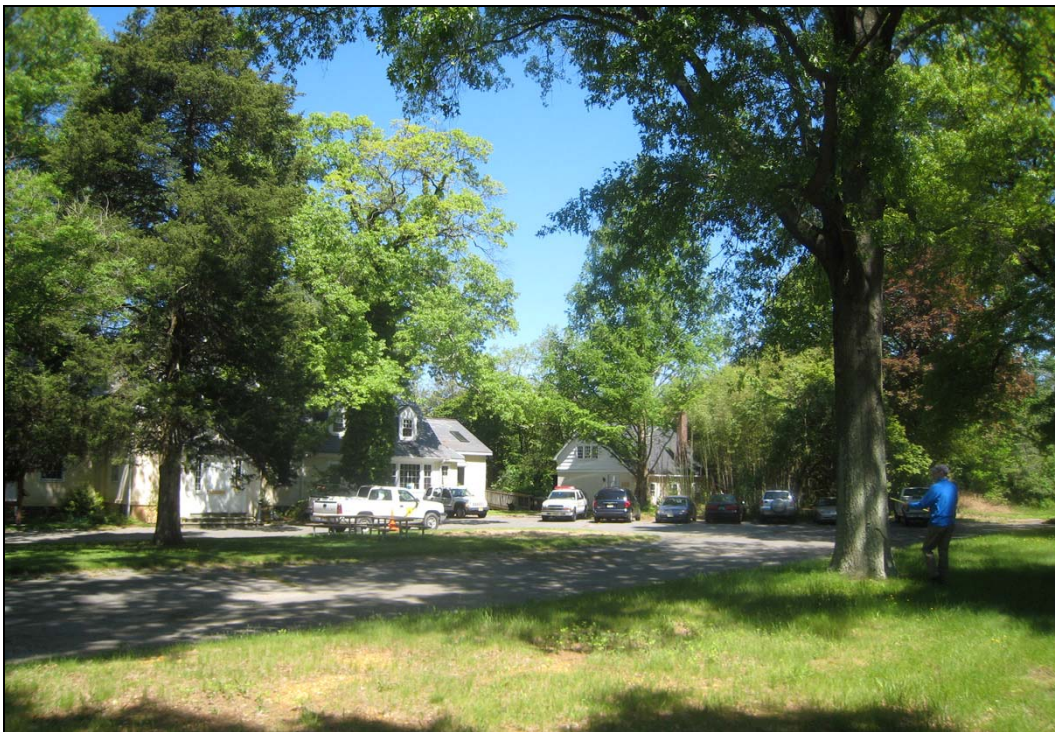
Figure III.16. Some of the plantings in the entry landscape are depicted here. Several mature trees grow within two mown turf islands. Additional plantings at the office and former blacksmith shop are also evident. Courtesy Heritage Landscapes. (R-PRN-19May09-0043.jpg)

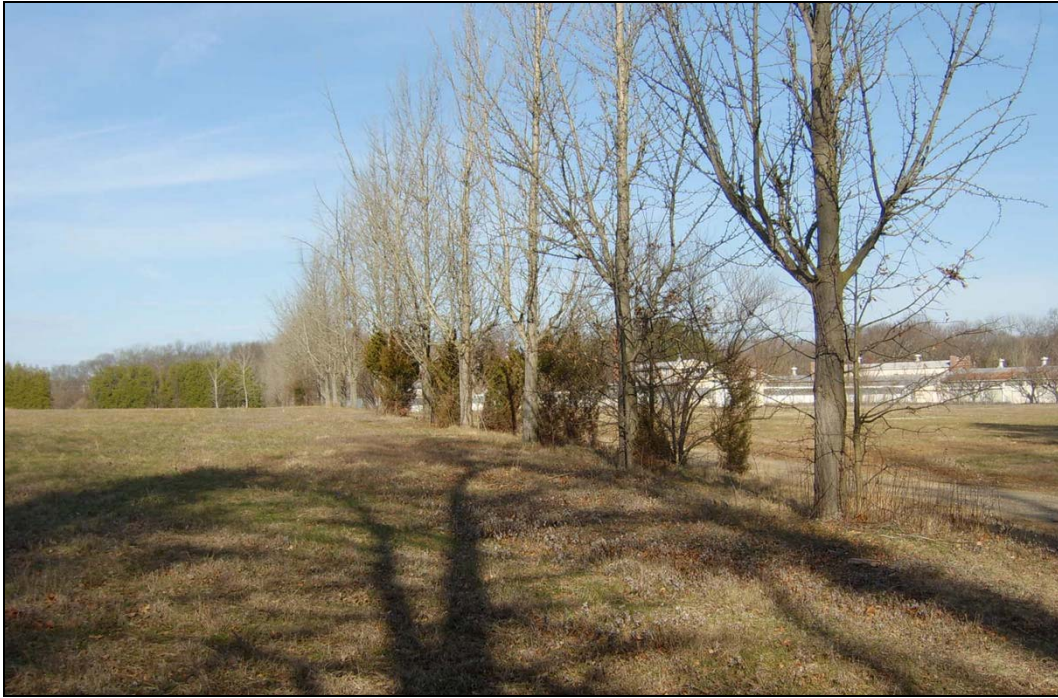
Figure III.17. A row of Princeton Sentry ginkgo continues to line the extant gravel road that extends east from the entry landscape and into the former nursery core. Courtesy Robert von Zumbusch. (R-PRN-RvZ-07013 D9-004.jpg)

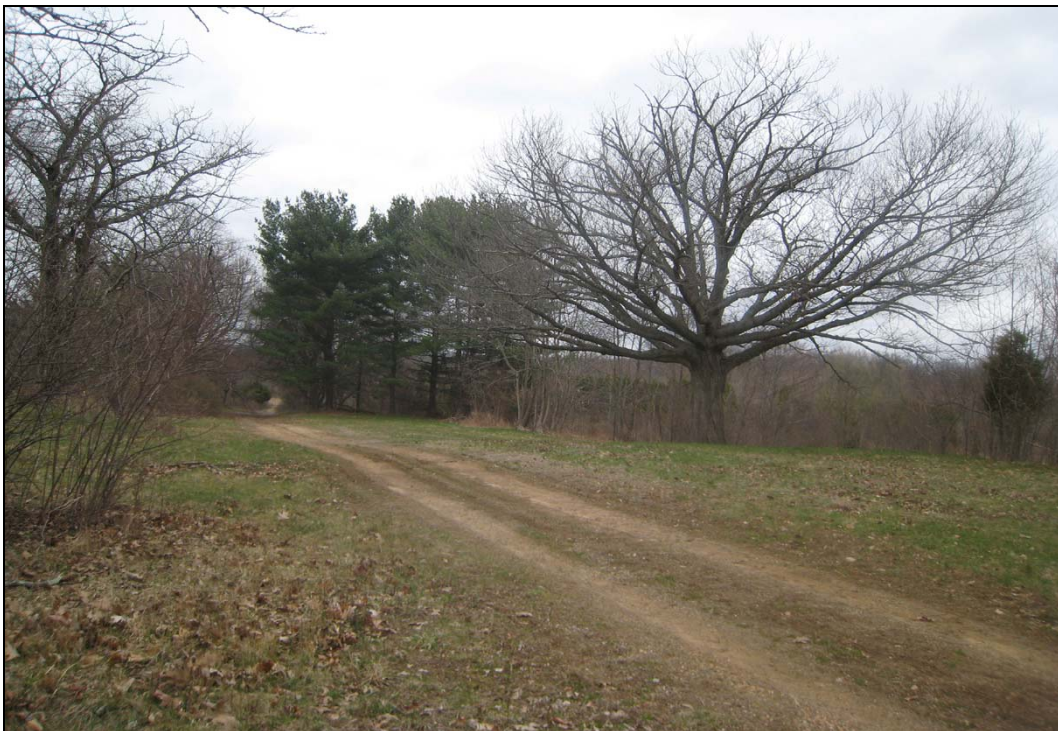
Figure III.18. This large, spreading red oak that grows alongside a compacted dirt road remains as a specimen tree today, marking the northern edge of the former worker dormitory building cluster. Courtesy Heritage Landscapes. (R-PRN-Apr09-0044.jpg)

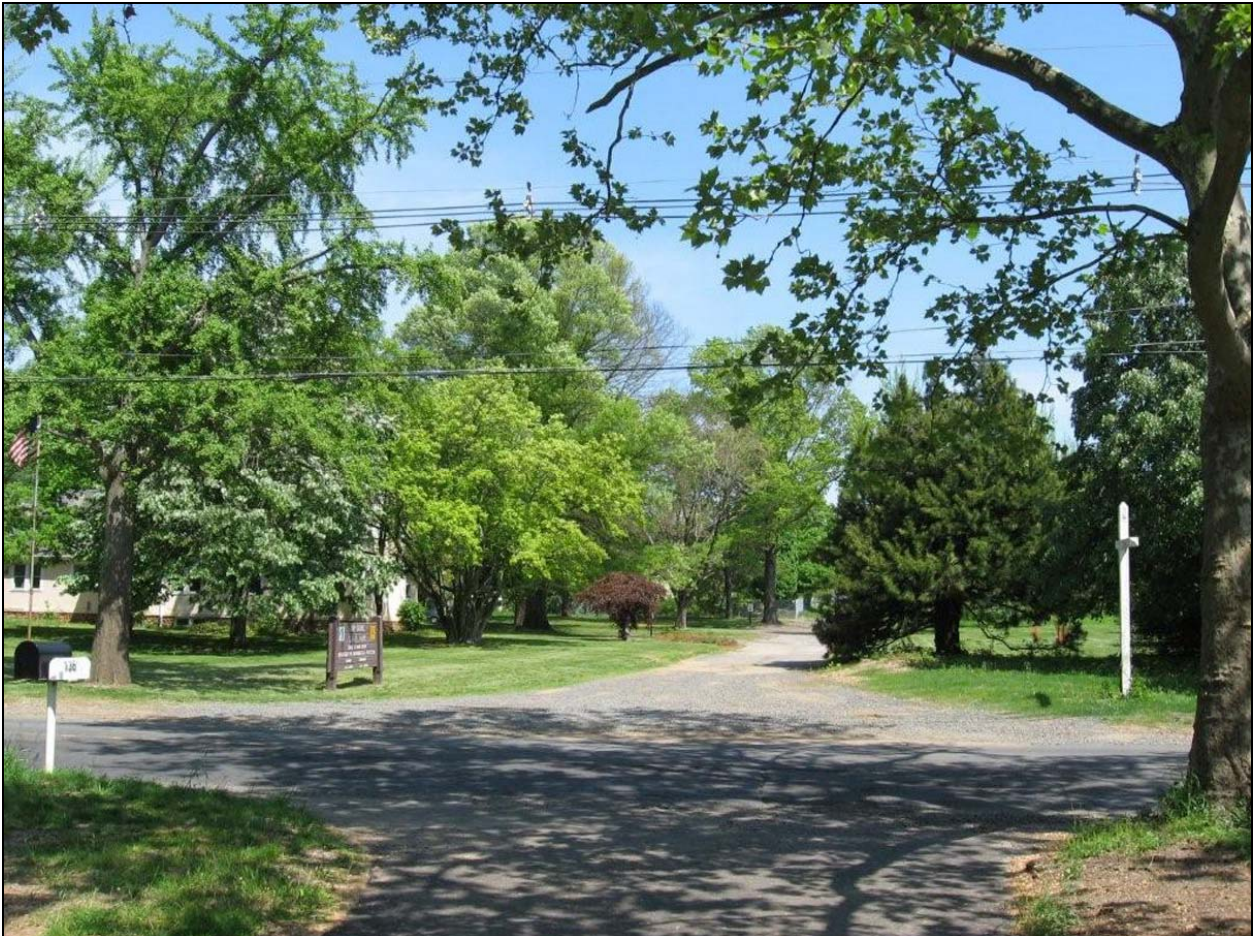
Figure III.19. This view looks east across Mapleton Road and toward the entry landscape for both the Mapleton Preserve and the D&R Canal State Park headquarters. Mature deciduous, evergreen, and ornamental plantings enhance the entry experience. Courtesy Robert von Zumbusch. (R-PN-RvZ 003 (1).jpg)

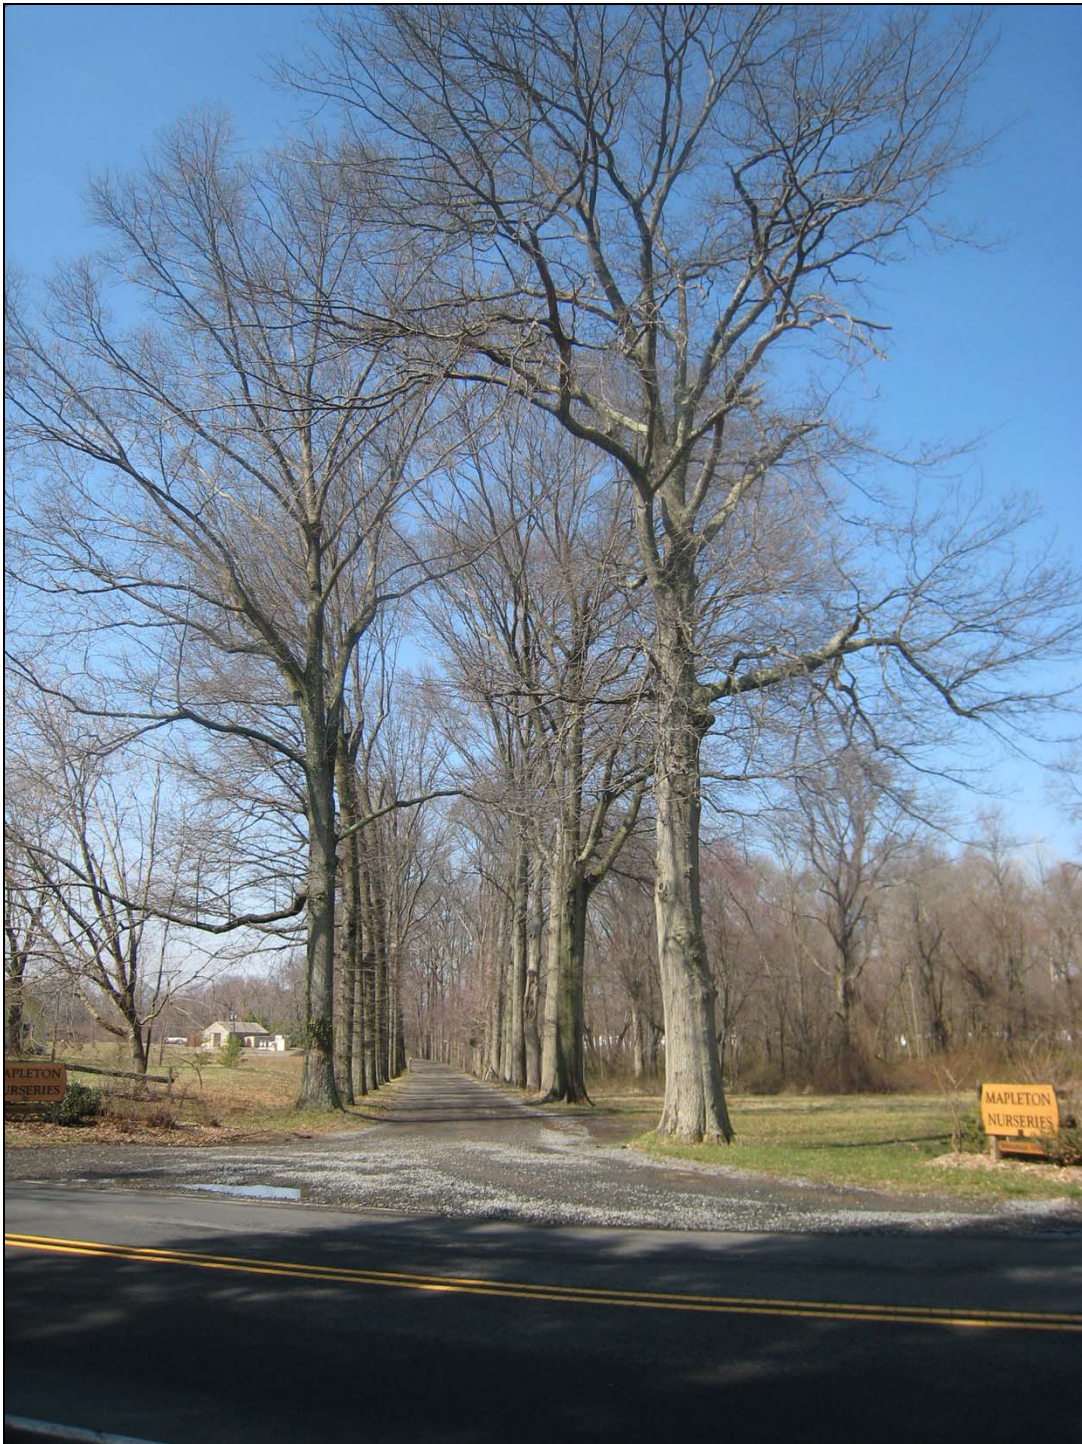
Figure III.20. Remnant plantings are evident in the landscape surrounding the preserved lands. This dramatic oak allée was planted by William Flemer Jr. and today lines the entry road to Mapleton Nurseries. The road is on the bed of the former Camden & Amboy Railroad. Courtesy Heritage Landscapes. (R-PRN-2Apr09-0011.jpg)

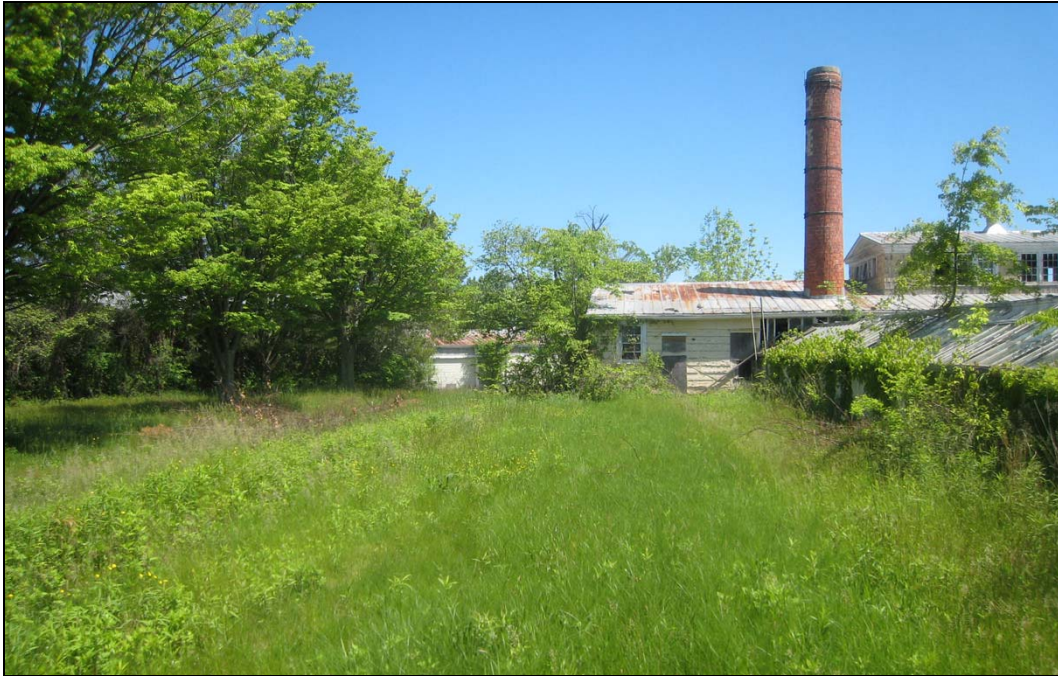
Figure III.21. The ground plane within the chain link fence enclosure is maintained less regularly than the surrounding area. Here, mixed species turf grows to about one foot tall at the west side of the propagation house and greenhouse. Courtesy Heritage Landscapes. (R-PRN-19May09-0057.JPG)

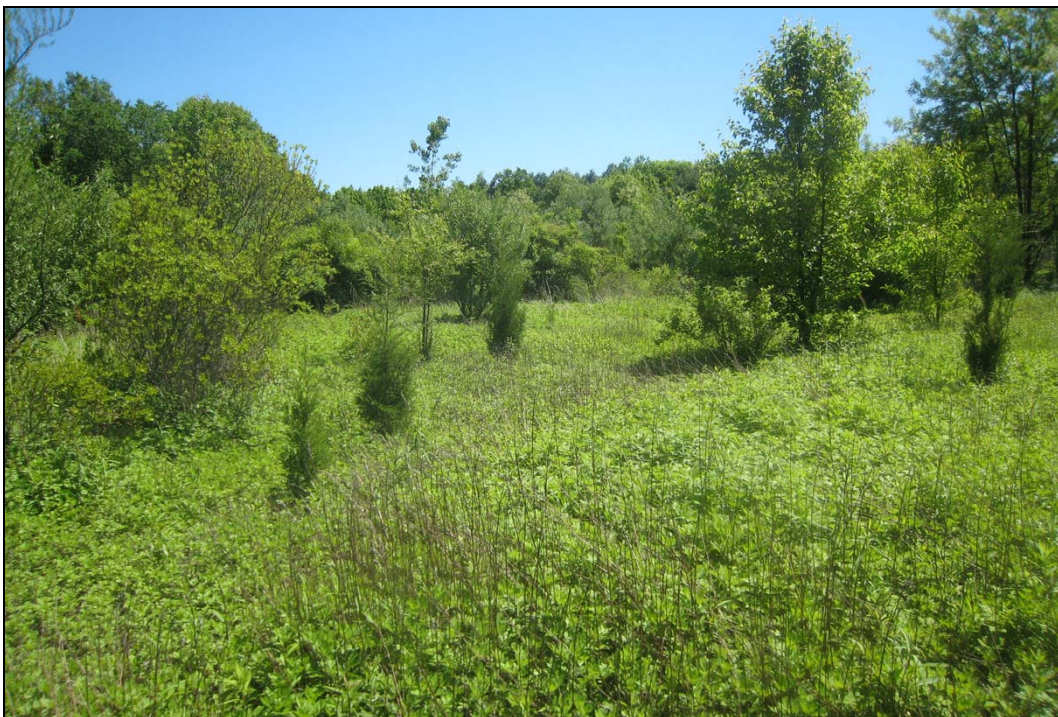
Figure III.22. Dense volunteer vegetation, including woody growth, covers this former production field, making accessibility to pedestrians difficult. Courtesy Heritage Landscapes. (R-PRN-19May09-0114.JPG)
